Extreme Road Repair

Across the State of Missouri, UPM® Permanent Pavement Repair Material has demonstrated positive performance in multiple applications. Following is the most recent application within the St. Louis area. The demonstration located at 10282 Riverview Dr. in St. Louis, MO is a known problem area. The local maintenance district was interested in using UPM due to recent successes.

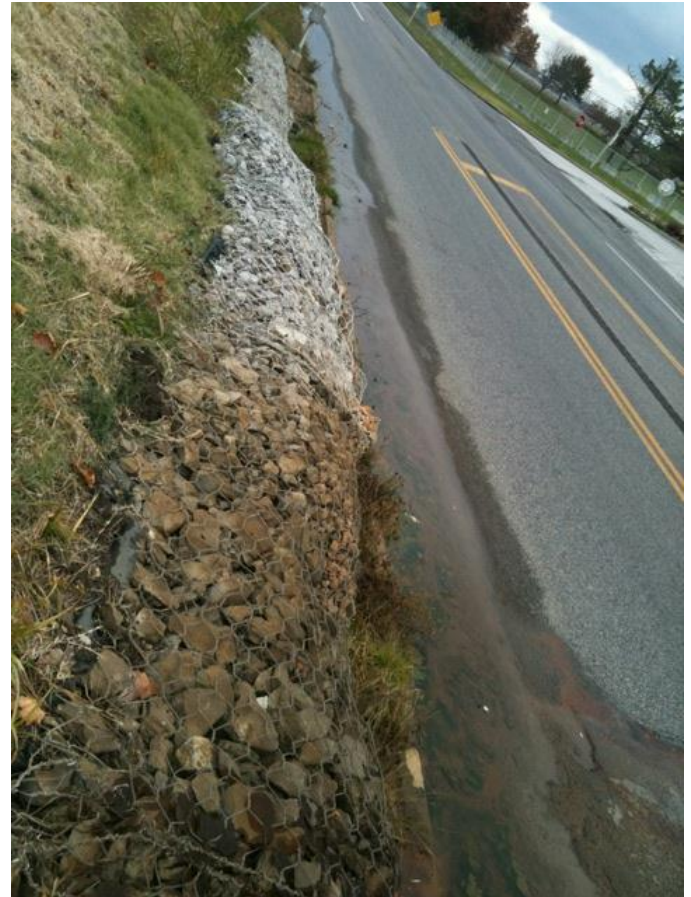
Prior to installing UPM, the site required re-repair about every 10 days. The labor and equipment commitment to this single location was excessive, negativity affecting the maintenance budget. This site was especially challenging because the roadway is subjected to an unusual combination of surface water and water permeating up through the road material due to hydrostatic pressure. The road is located at the base of a hill where the water flows, through the hillside on the left, and onto and under the roadway. The roadway is constantly wet. The photo shows water running down the side of the road to a catch basin north of the repair site.

The constant water flow caused the HMA and locally available cold mixes to prematurely fail frequently.

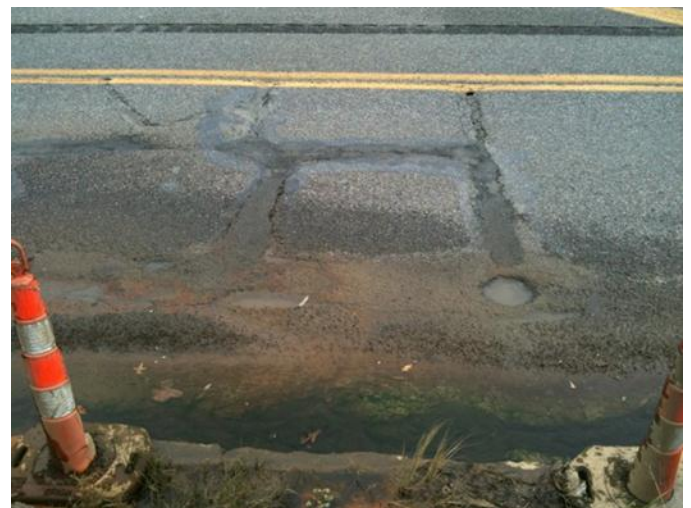
The following picture shows road condition prior to installing the UPM. The photo shows the original pavement failed, as well as, several attempted repairs.

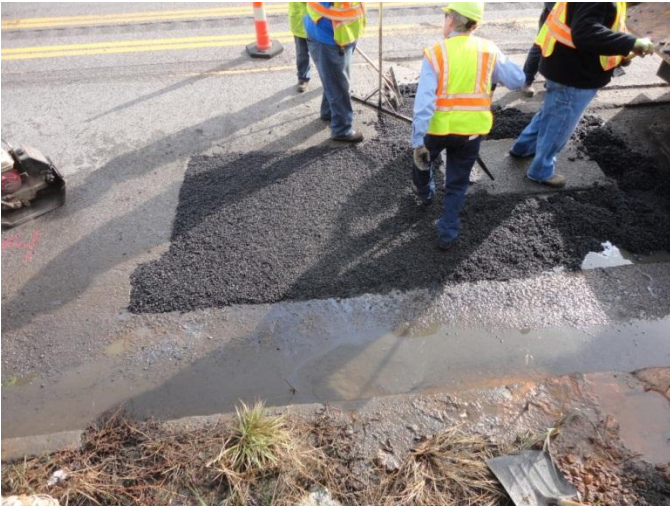
Sections of hotmix were left in place to use as a control material and to compare performance to UPM. Looking closely you can see the water seeping up through the HMA into the recently milled areas.

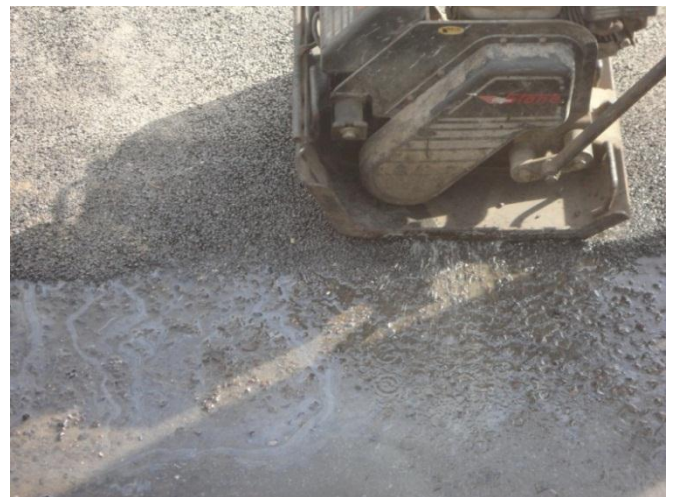
During the compaction process water from under the road surface was forced out of the repair. Compaction was accomplished using a commercial vibratory plate compactor shown below.

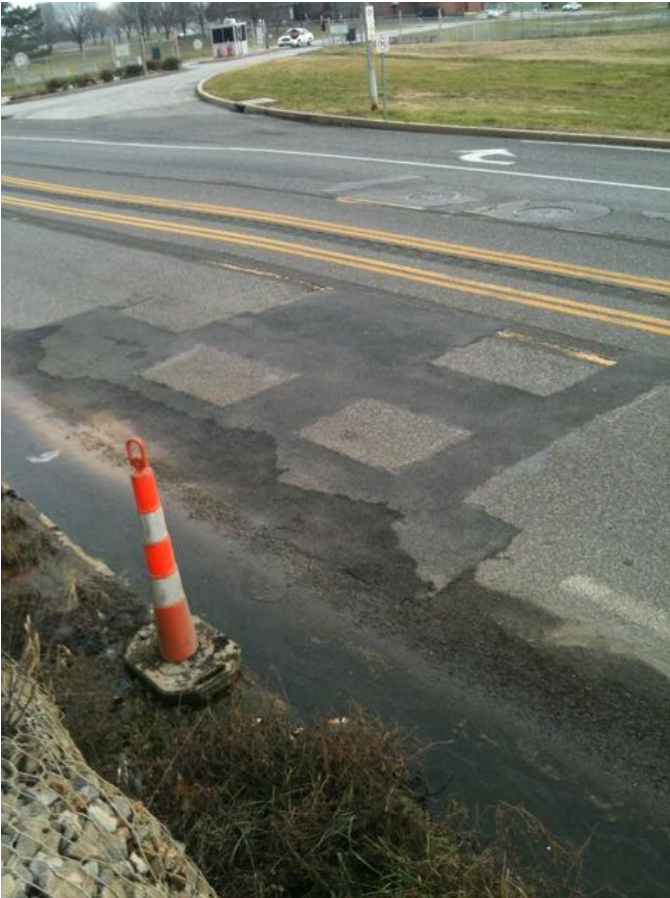
Monitoring challenging repairs is part of the UNIQUE follow-up QC program to verify performance. The condition of repair material after 3 weeks, shows no sign of material loss, raveling or pushing. The repaired area remains wet, but the UPM repair is intact. No

sign of raveling, dishing, lost material or stress.

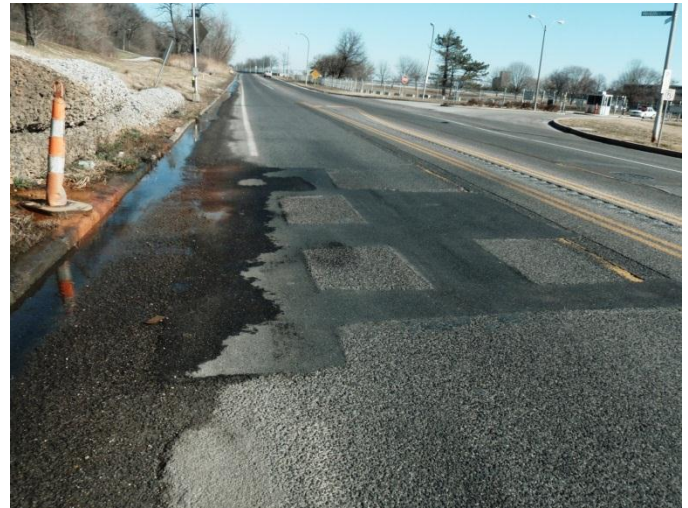
The above photo is repair site at 7 weeks after installation. The UPM repair remains rock solid. Again, no sign of raveling, dishing, loss of material or stress.

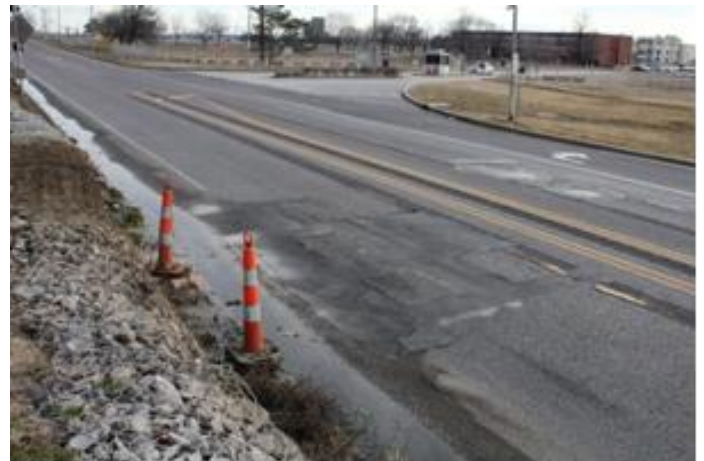
After 11 weeks, UPM is performing as above expectations with no sign of raveling, dishing, and loss of material or stress even with the presence of constant water.
