Extreme Road Repair

Across the State of Missouri, UPM® Permanent Pavement Repair Material has demonstrated positive performance in multiple applications. Following is the most recent application within the St. Louis area. The demonstration located at 10282 Riverview Dr. in St. Louis, MO is a known problem area. The local maintenance district was interested in using UPM due to recent successes.

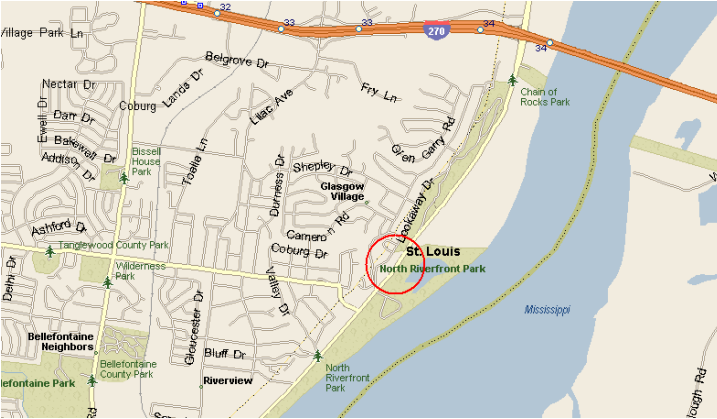
Prior to installing UPM, the site required re-repair about every 10 days. The labor and equipment commitment to this single location was excessive, negativity affecting the maintenance budget. This site was especially challenging because the roadway is subjected to an unusual combination of surface water and water permeating up through the road material due to hydrostatic pressure. The road is located at the base of a hill where the water flows, through the hillside on the left, and onto and under the roadway. The roadway is constantly wet. The photo shows water running down the side of the road to a catch basin north of the repair site.

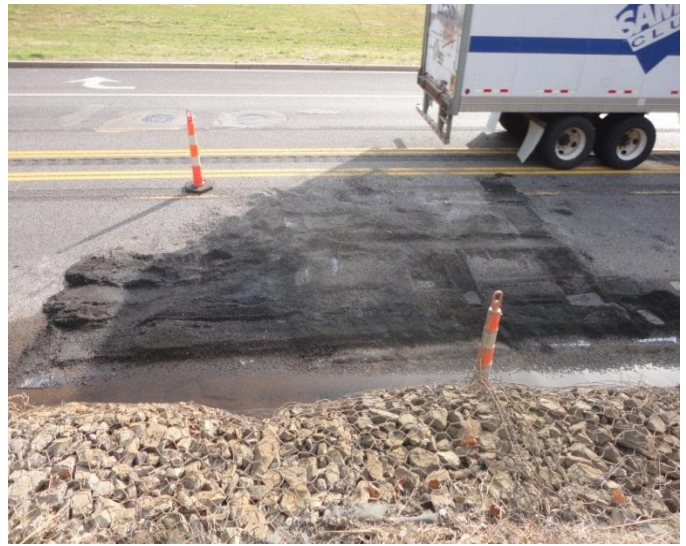
This extreme site demanded a solution; the constant re-repairs were not an acceptable resolution. MoDOT needed to resolve this re-repair problem and free-up resources for other maintenance activities.

The loose millings were removed.

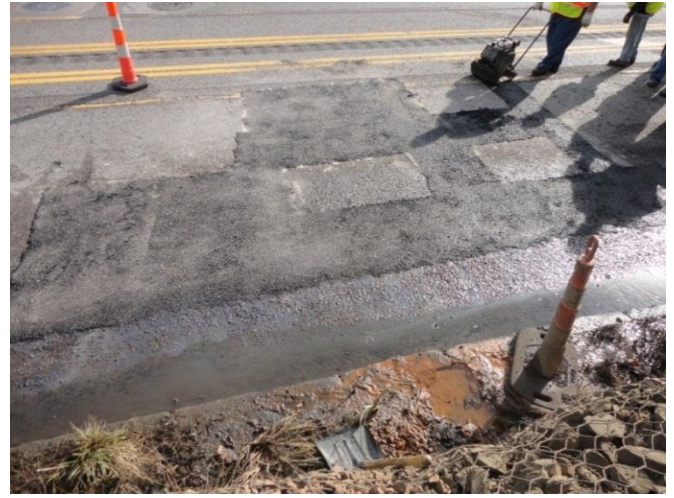
The UPM design differs from other cold repair materials. Initially developed in 1959, the UPM design criteria focuses on maximum survivability with a robust QC program to maintain target performance. As the original High Performance Repair Material and most tested throughout the US, UPM is recognized throughout the industry as the performance bench mark. Other cold applied repair materials focus on price or available aggregate and cutback, omitting the design process. Each UPM production is managed like an HMA production; all parameters affecting survivability are tightly controlled. Using a pre-qualified aggregate, UPM was produced following a custom recipe at the NB West Contracting location, the local authorized producer in the St. Louis area. This is the material used in the repair. It was shoveled off the truck and raked to a uniform height before compacting the mix.

During the compaction process water from under the road surface was forced out of the repair. Compaction was accomplished using a commercial vibratory plate compactor shown below.

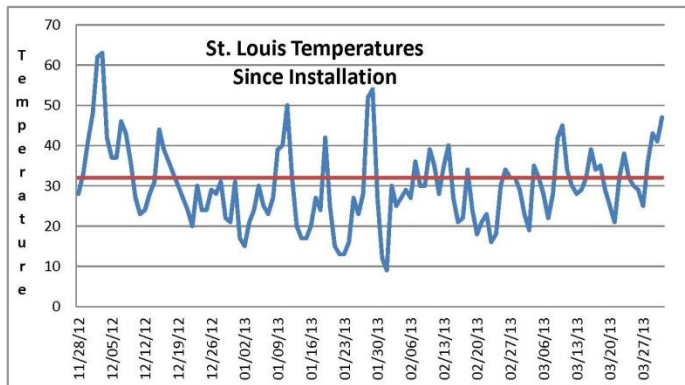
After 11 weeks, UPM is performing as above expectations with no sign of raveling, dishing, and loss of material or stress even with the presence of constant water.

had several freeze thaw cycles in the 77 days with temperatures below freezing. This also included 30 days of snow as well as 30 days of rain. Without any affect, on the repair.
