Growth is Welcome but Brings Challenges—Jones Twp., Wilcox PA Solves Road Repair Problems with UNIQUE Products and Service from Delullo Stone Co.

<u>April 2013</u>

The subject of this case study is a substantial failure of the road surface as a result of heavy truck traffic and a deteriorating road base.

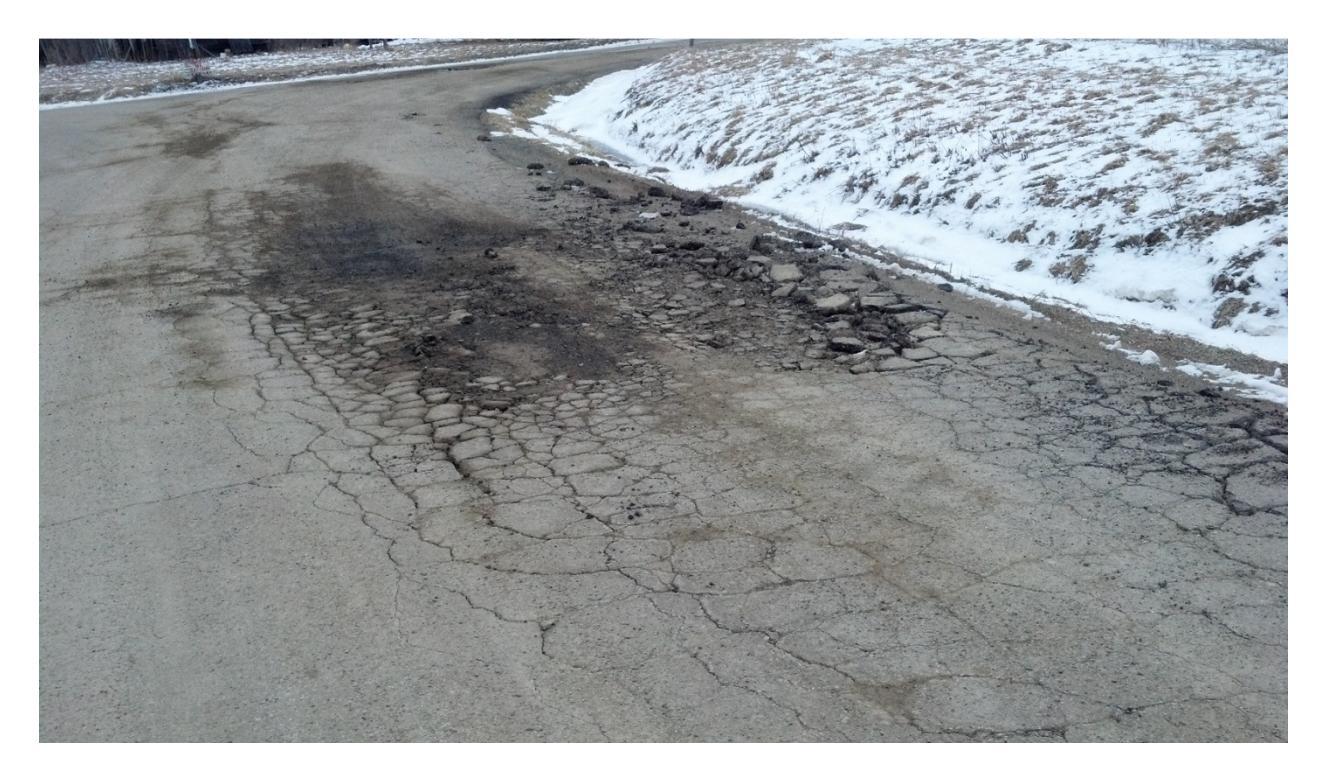
detours are typically 4-6 hours in duration, and have happened often within the past year. As a result of this excessive wear-and-tear, Lamont Rd. is deteriorating at a rapid pace, and the picture below illustrates one such example.

The repair highlighted in these photos is Lamont Rd at the corner of Highland Rd. Extensive heavy-load truck traffic has literally crushed and disintegrated previous repairs and the asphalt surface to the point of complete failure.

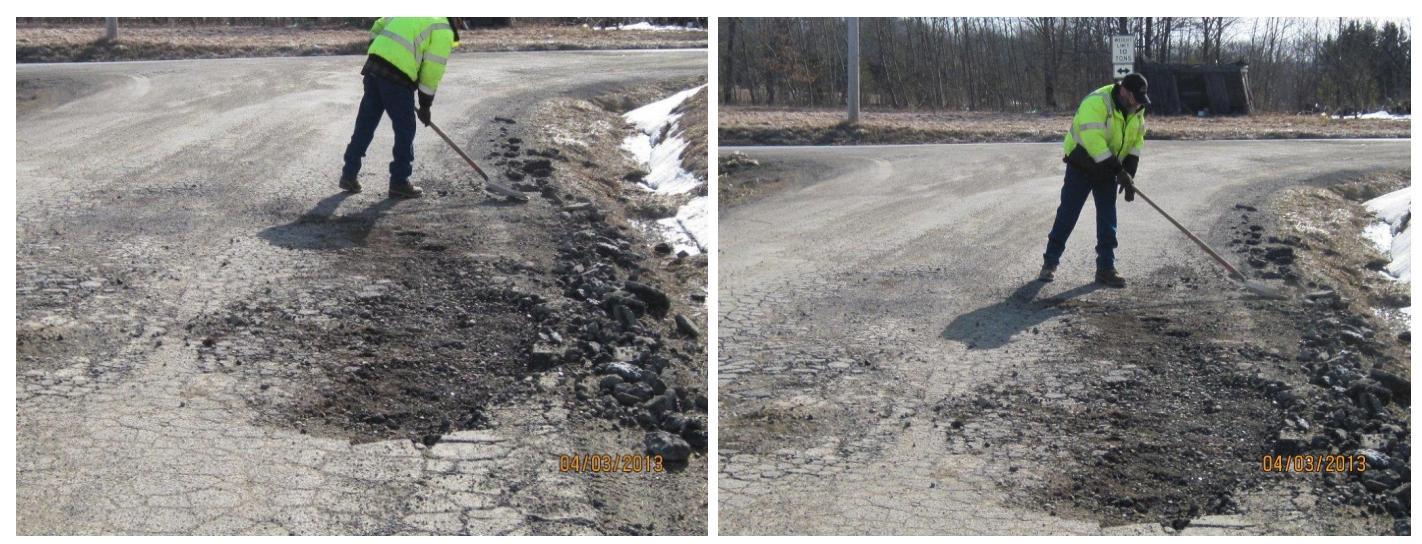
Jeff Roberts removing failed chunks of asphalt from the roadway in preparation for installing UPM.

Prior to installing the UPM the following day, the road surface was prepared by removing as much loose debris and failed cold patch as possible. By creating as solid base as they could, the best potential adhesion could be achieved .between the UPM and the remaining roadway base and surface.

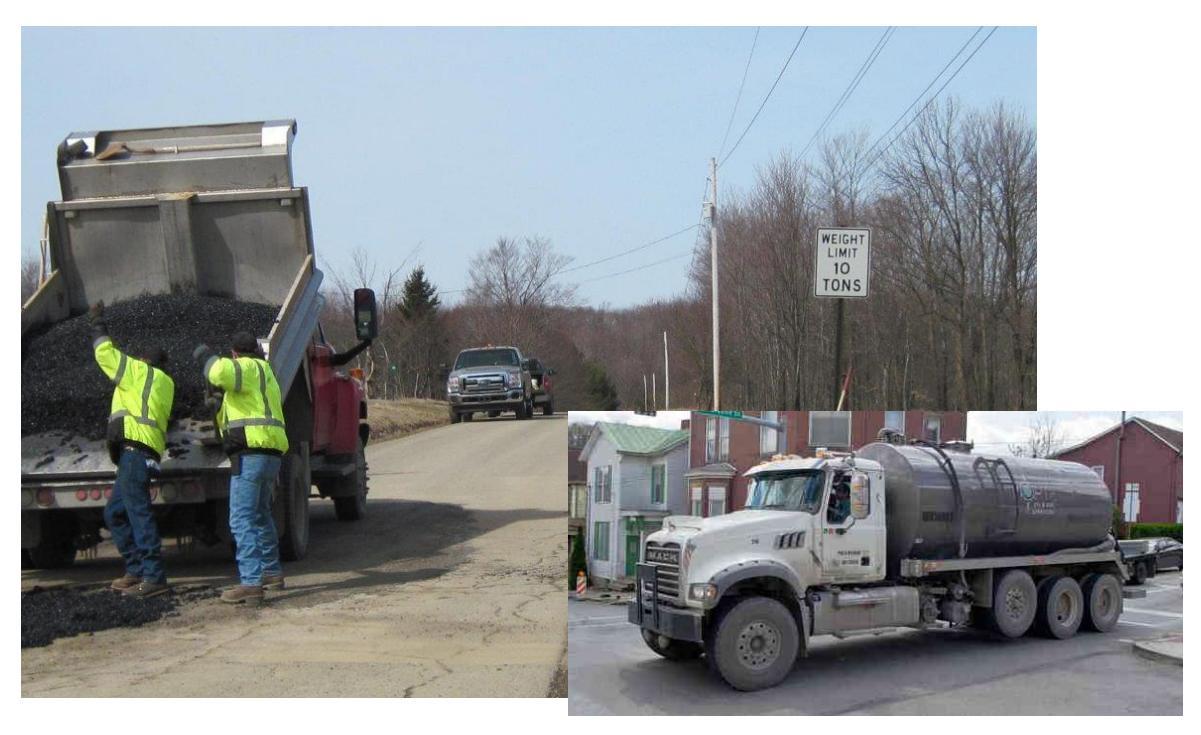
A single water tanker load can weigh 25 tons, far exceeding the design capacity of this road.

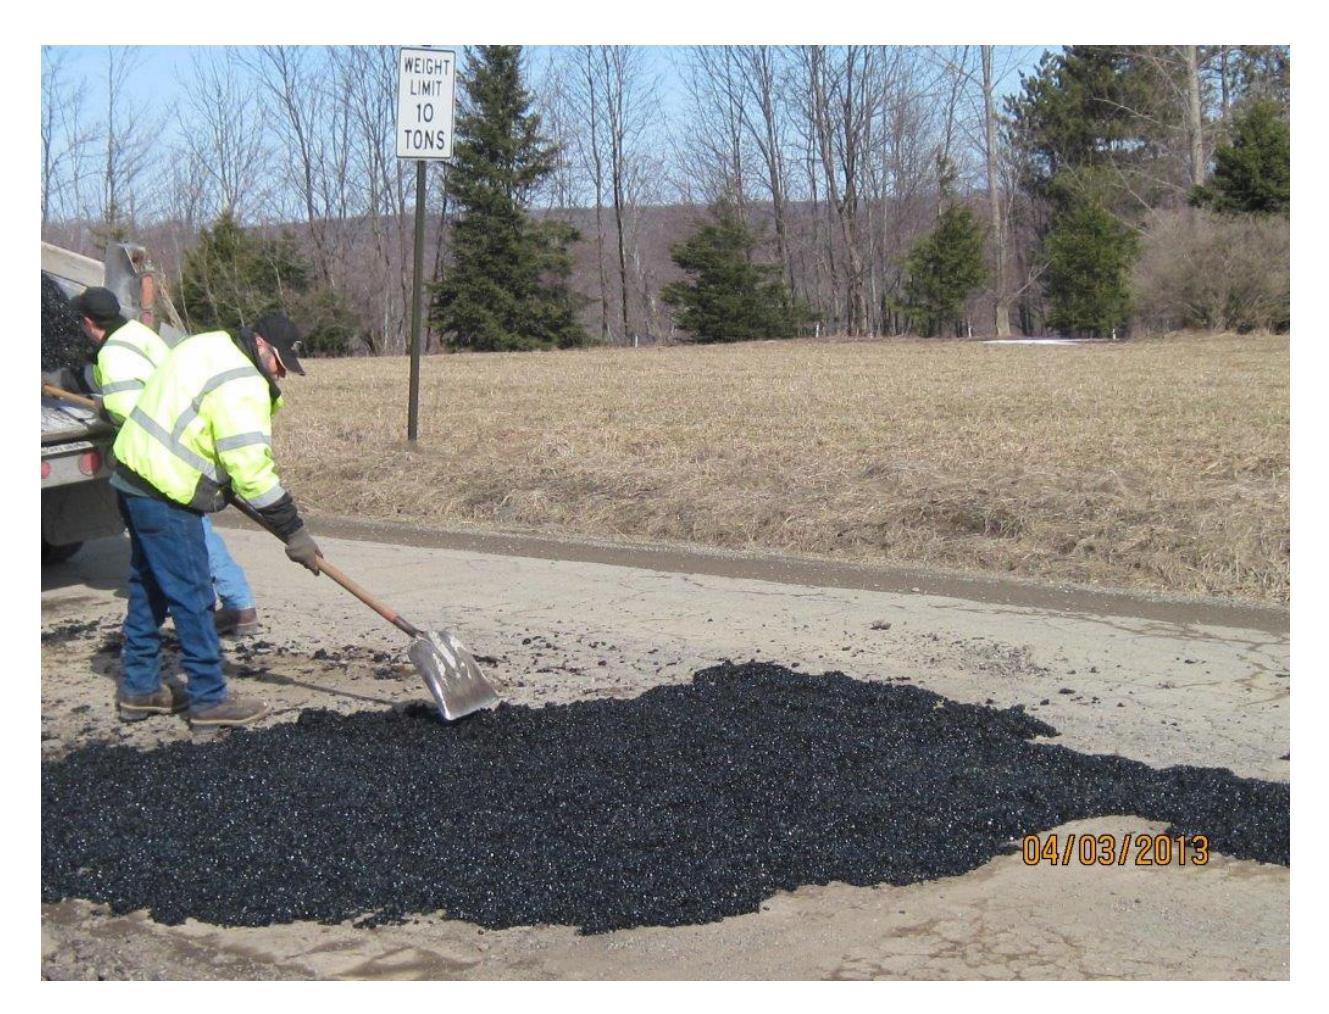
Because UPM is produced in seasonal grades including a winter formulation, road crews can easily work with and install material to make necessary repairs, even in 35-degree weather.

The morning of April 4th, the temperature was 35°F when repairs were begun around 9:00 a.m. Other cold patch products are hard-as-rock and completely unusable in such conditions. However, UPM is manufactured specifically in multiple seasonal grades, to ensure the material remains workable and pliable for the road crew personnel installing it. Jeff and crew were pleasantly surprised and commented on the ease and handling of the winter-grade UPM compared to products used previously.

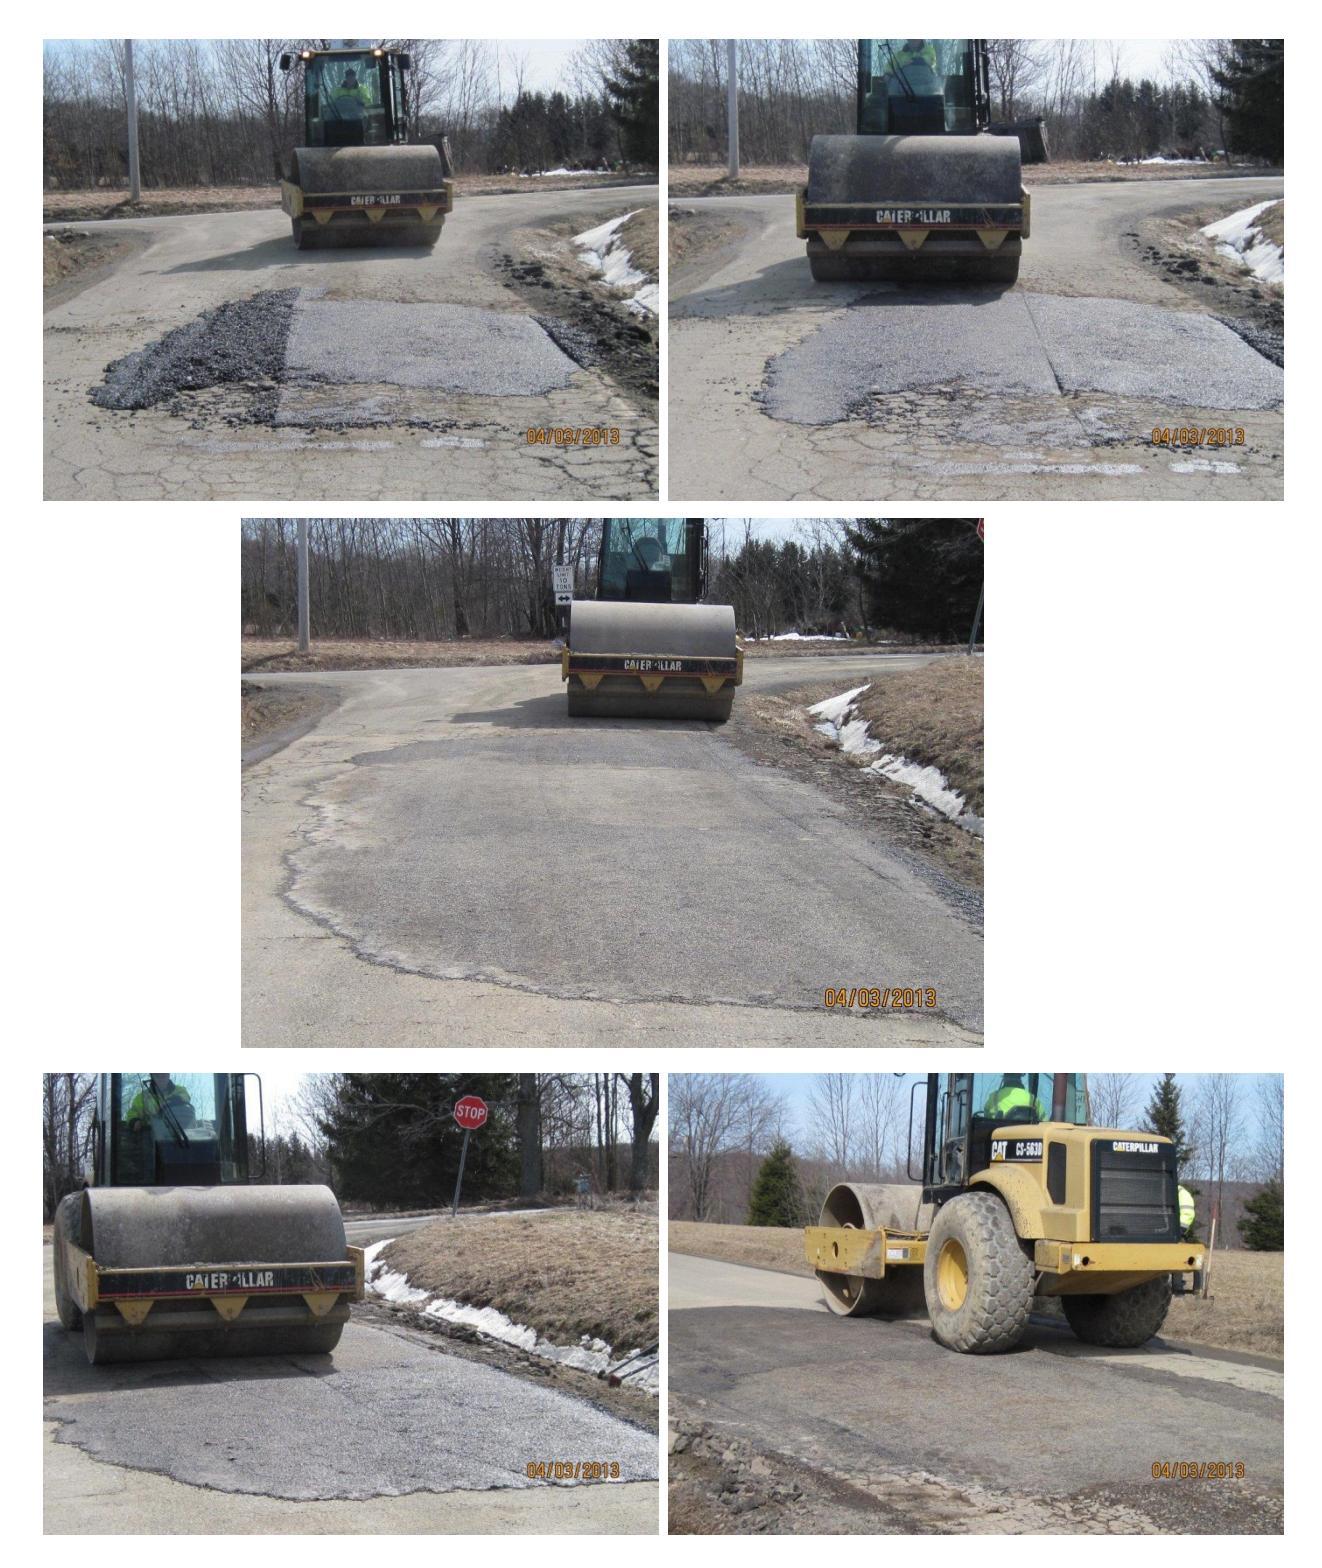
Good compaction is essential to properly achieving the bonding and strength of UPM, and using a roller is beneficial but not the only means of compaction.

After the UPM material was shoveled into the repair area, it was compacted using the city's street roller. Compaction is essential to the effective performance of UPM, by removing excess air voids and maximizing the adhesion, (sticking to the pothole walls, floor, and road surface), and cohesion, (sticking to itself) properties of the UPM chemistry.

Although a street roller was used for compaction in this case, it is not the only means of compaction—UPM can be conveniently compacted by using a plate tamper, hand tamper, or by simply rolling the truck tires back and forth over it a few times.

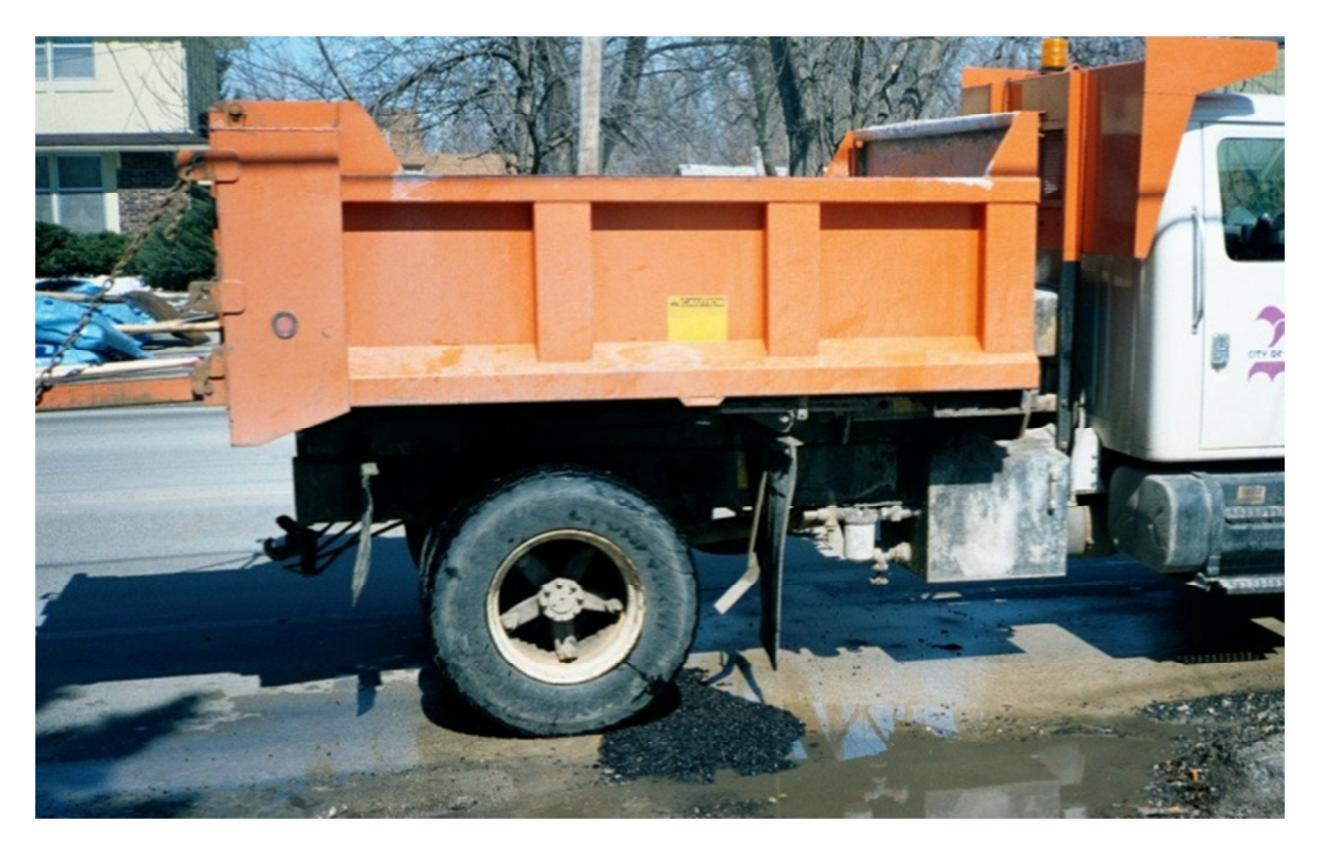
Another popular and effective method of compacting UPM is truck-rolling.

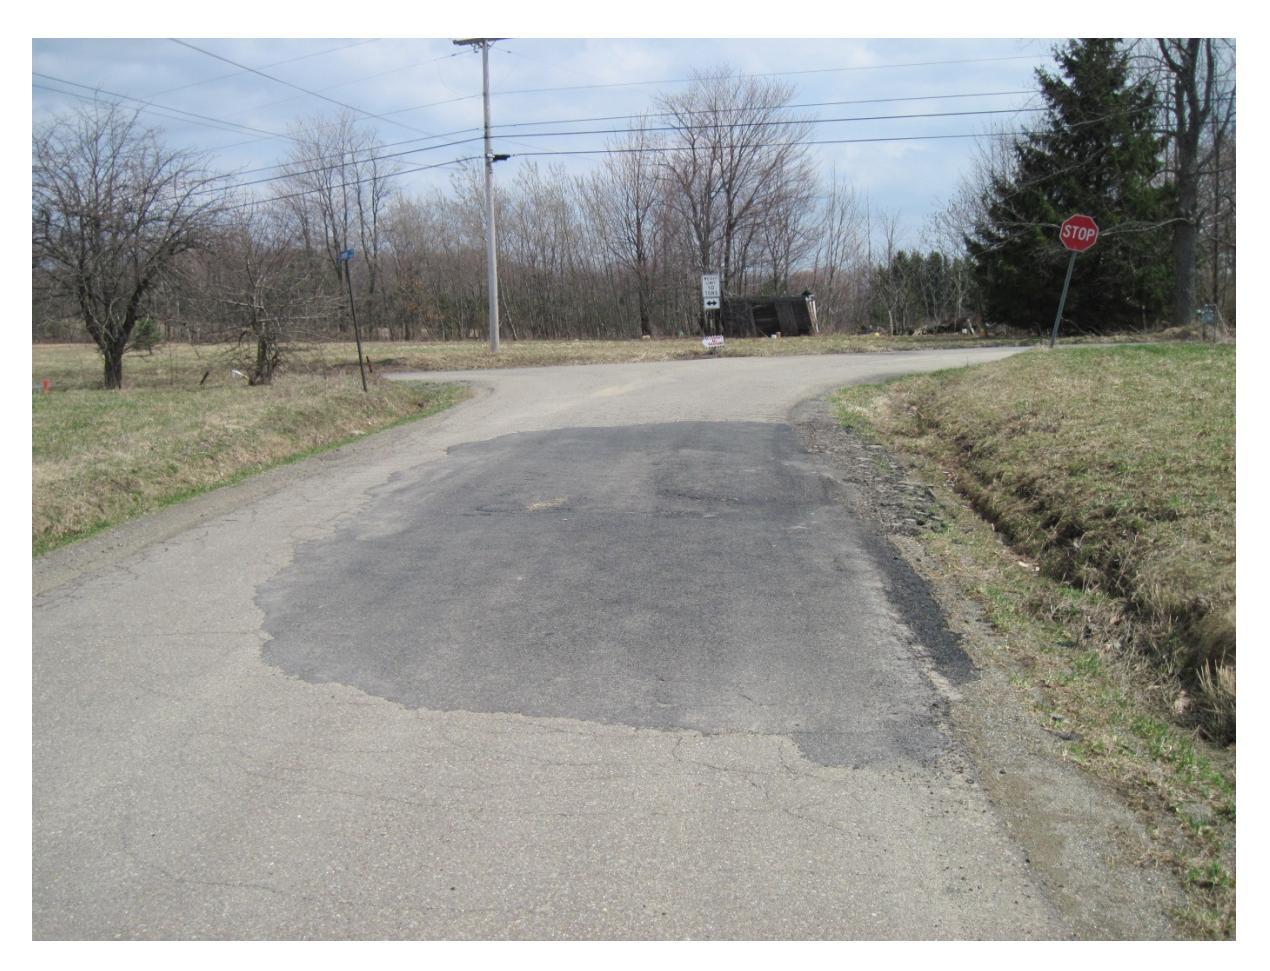
After several weeks of ongoing heavy truck traffic, the subject repair area shows the UPM is still holding solid, with no cracking, breaking, alligatoring, or other failure, as shown in picture.

The initial repair of UPM continues holding strong, showing no signs of asphalt failure.

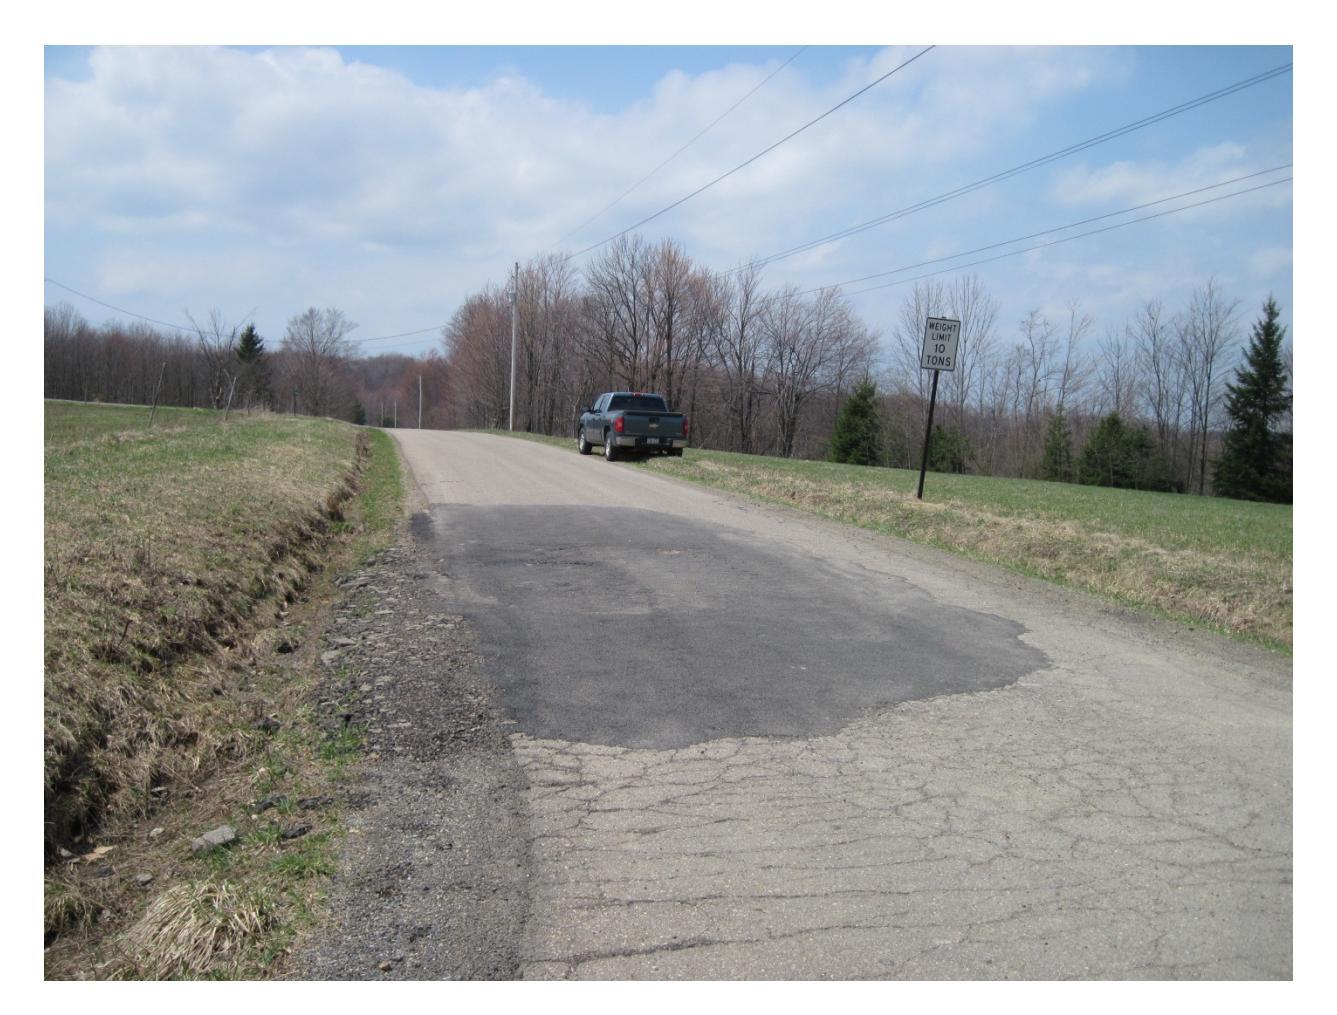
The importance of having a solid, stable base for effective repairs is also clearly illustrated in this case, and a weakened, deteriorating, and unstable base is one of the primary causes of roadway failure. If the base is unable to support the loads to which it is subjected, the roadway above the base has a high probability of eventual failure. Fortunately, UPM provides the highest degree of flexibility of any road repair material in overcoming such problems. (See picture below.)

Because of the flexibility of UPM, the repair did not break or crack like other materials, but instead flexed and "rode" the depression caused by the failing road base. Additional UPM will correct this depression back to level of road surface.

At the middle of the repair on the side nearest the berm, it is clearly visible that an area of approximately 3 feet by 3 feet has slightly sunk because of a weakened base. Ideally, prior to the repair using UPM, the affected area should have been dug out to the depth of the road base, and the weakened base material removed and replaced. However, there was simply no time to undertake a full-depth repair in this case. As a result, the traffic has compacted the road surface further down towards the base.

At this point, other repair materials would have failed on the surface—the surface compaction would have cracked and broken hot-mix asphalt, as well as conventional cold patches because they lack the flexibility to move and the cohesiveness to bind together. However, because of the flexibility of UPM, it simply "rode" the depression, remaining completely intact, solid, and crack-free. Further, because of its specific design chemistry, UPM has the unique characteristic of bonding to itself. Therefore, to repair this depression, the town need only install additional UPM, which will be documented in further updates to this case study. Stabilizing the failing area stopped further deterioration of the surrounding alligator cracking, which would have eventually broke into the failure zone. This type of road repair creates the opportunity for a future chip and seal or overlay when budgets accommodate.
